HOT ISOSTATIC PRESSING REJUVENATION OF DISKS

AiResearch Manufacturing Company of Arizona
111 South 34th Street
Phoenix, Arizona 85010

TECHNICAL REPORT AFML-TR-79-4093

Final Report for Period 1 September 1977 to 31 May 1979

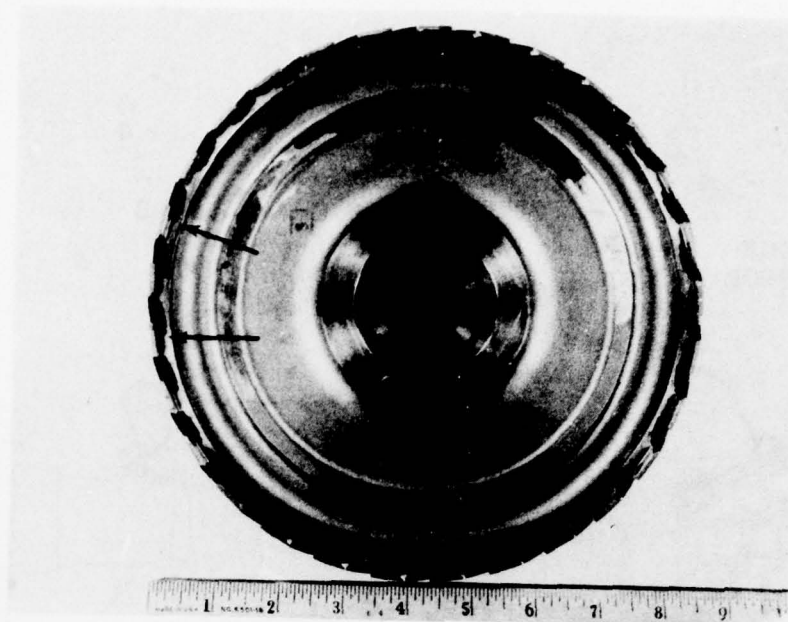
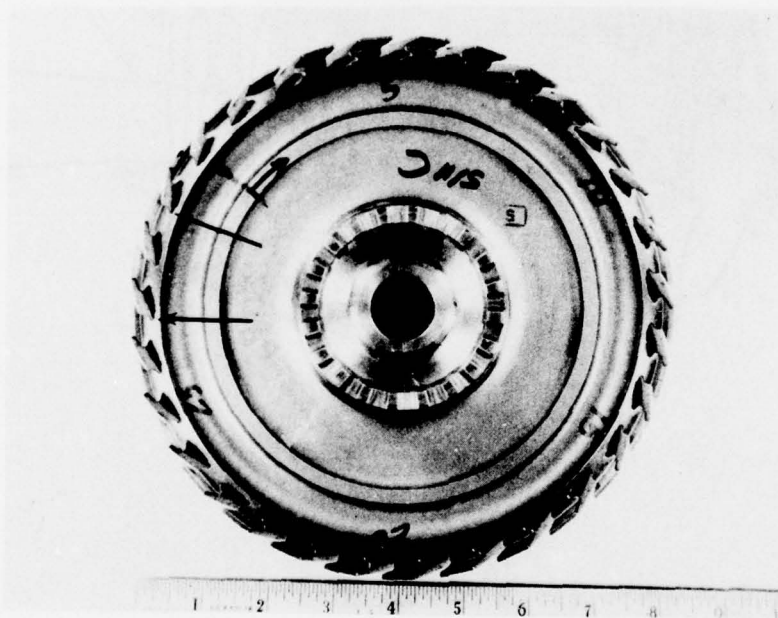
Figure 2. Retired First-Stage Compressor Disk from an AiResearch Model TSCP700 APU. Arrows Show Typical Locations of Fatigue Cracks.

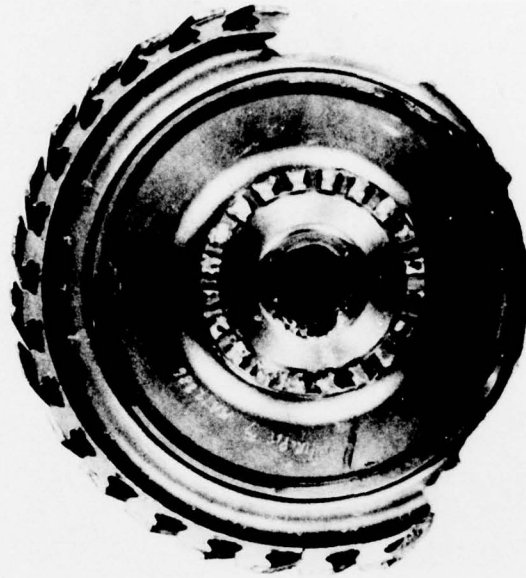
Figure 8. Ti-6Al-4V Compressor Disk Showing a Relatively Large Crack which has Propagated to the Surface (Left, Arrow) and the Result of Prolonged Cycling with a Crack Evident (Right) on the Surface.

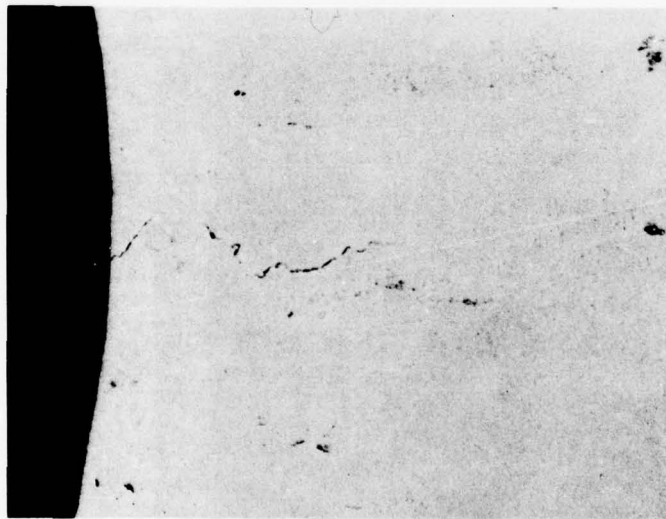
Figure 22. Low-Cycle-Fatigue Crack Produced in 6070 Cycles by Cyclic-Spin Testing at Room Temperature, Disk Serial No. 1799.

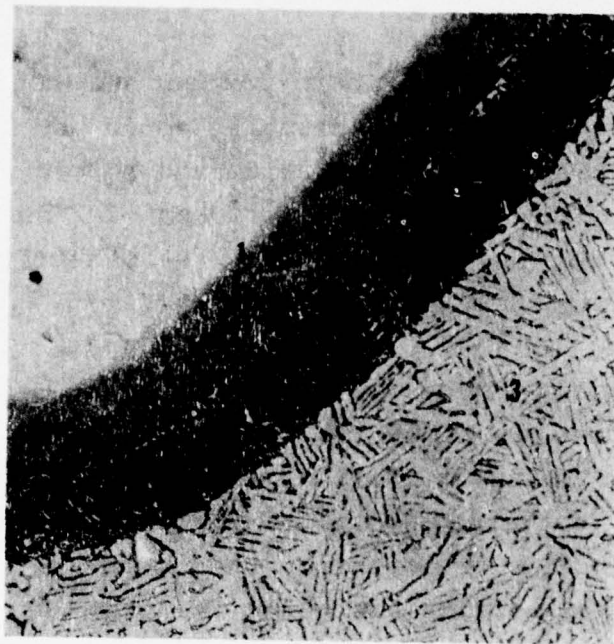
DISK NO. 4829 DOVETAIL NO. 16

The layer was identified, using TEM thin-film techniques, as stabilized beta with a fine distribution of small alpha and/or Ti_2Cu precipitates. Copper is a strong beta stabilizer. This beta layer was present on the internal surfaces of the dovetails but changed on the outside diameter of the disk. It appeared to be replaced by a white etching layer, as shown in Figure 42. Figure 43 shows Scanning Electron Microscope (SEM) images of the corner of a dovetail showing this transition from stabilized beta to the unidentified layer. X-ray analysis in the SEM detected a slightly higher copper content in the OD layer than in the beta, but was unable to detect other chemical differences due to the

Figure 40. Microstructure of HIP Rejuvenated Ti-6Al-4V Compressor Disk Dovetail Corner.

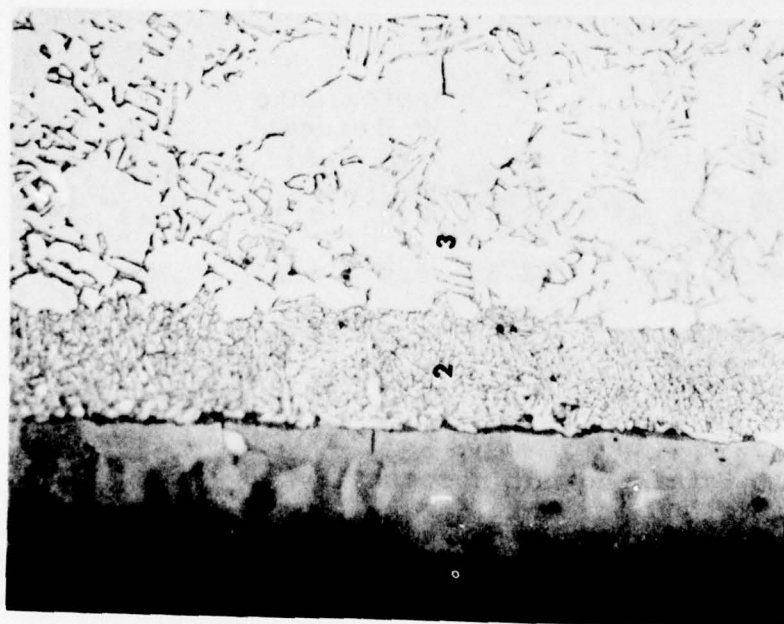
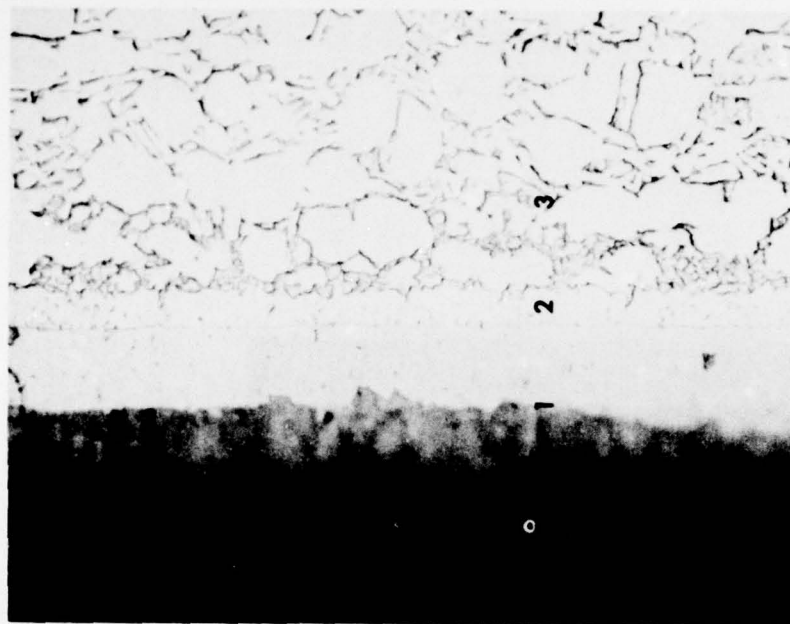
Figure 42. Surfaces of Disk S/N 1706 at the OD and at the Base of the Dovetail.

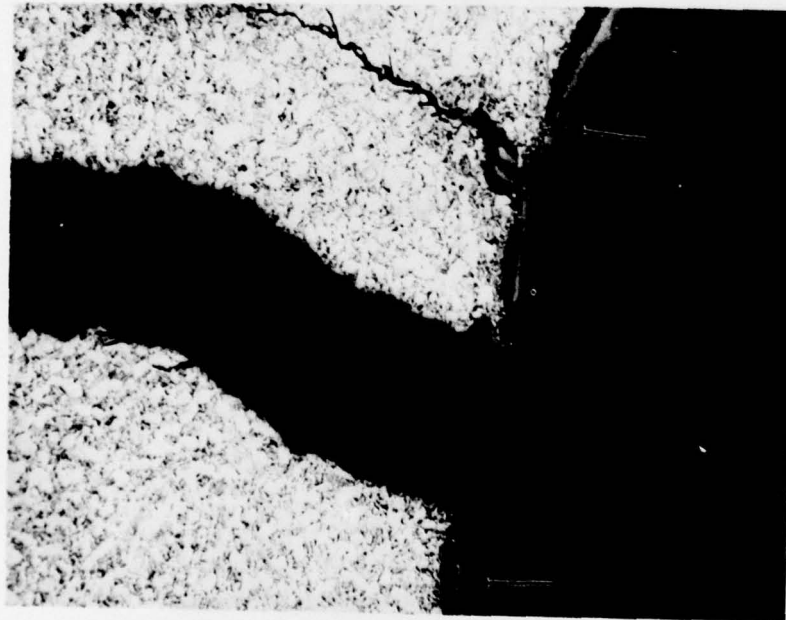
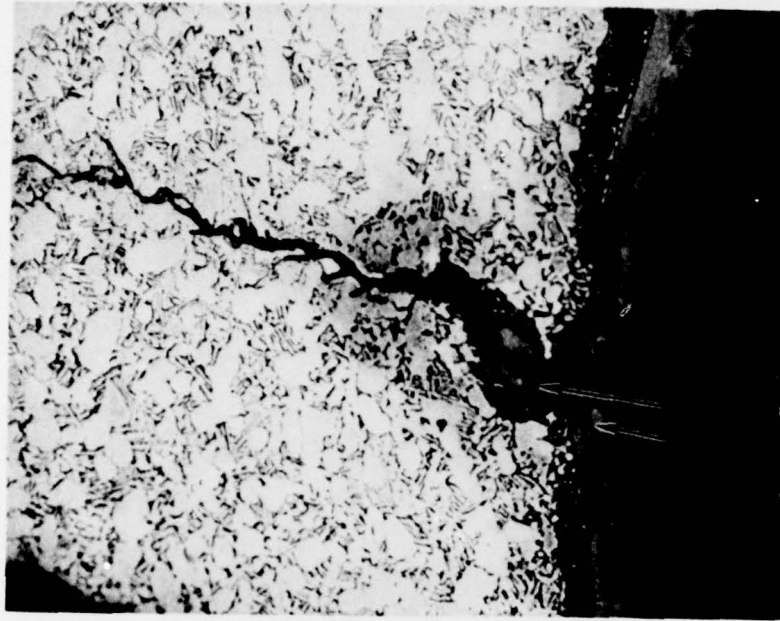
- A - Large Crack that was not Bridged Plus Small Crack.
- B - Small Crack from A with Bridge Material Forced into Crack.
- Arrows Show Bridge Material.

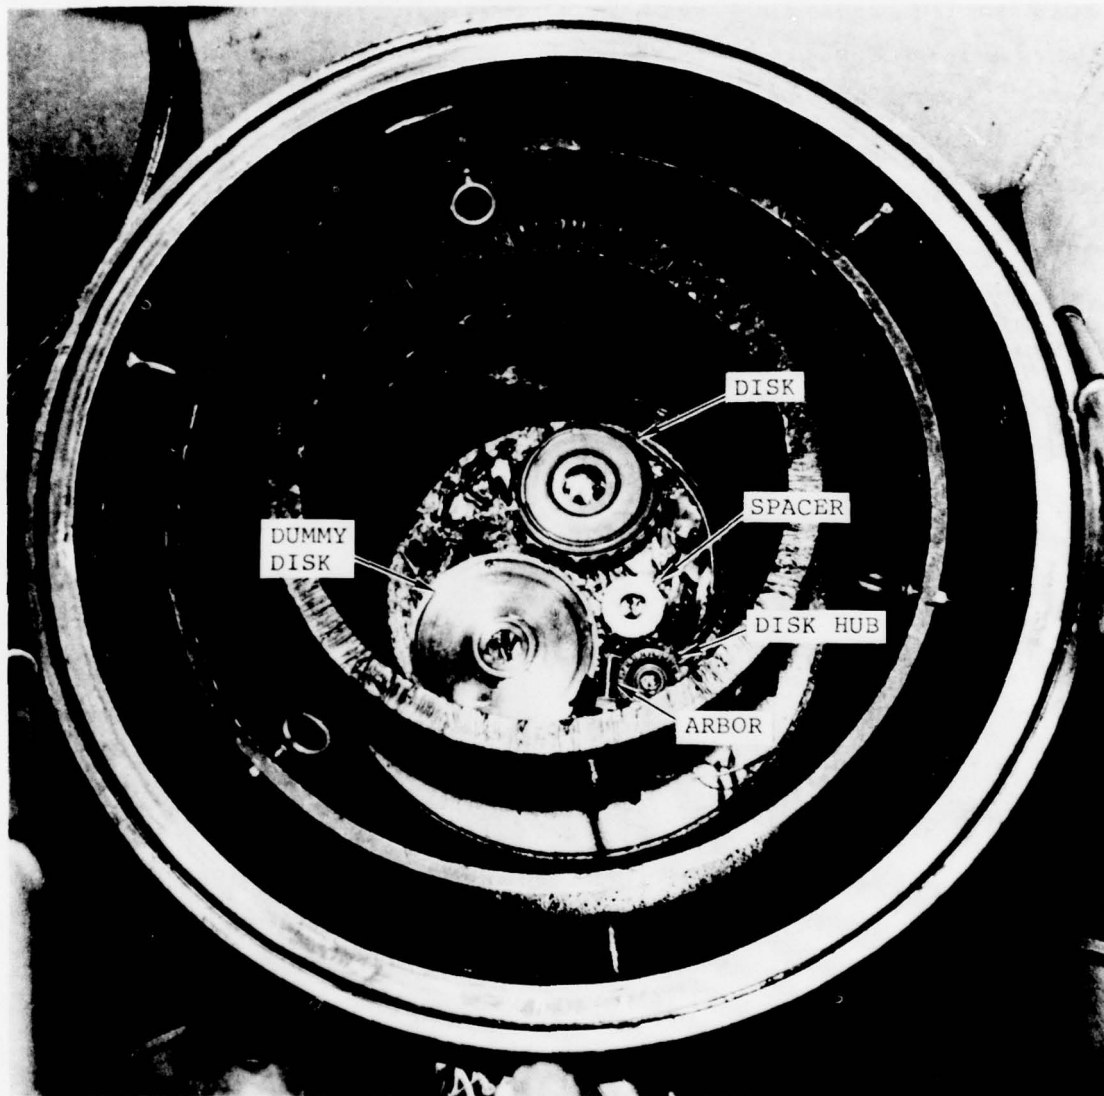
Figure 52. Ti-6Al-4V Alloy Compressor Disk S/N 717 Failure After 1410 Cycles in the Cyclic Whirlpit.

Prior to additional spin testing, the decision was made to attempt to remove the brittle stabilized beta layer by either chemically milling or utilizing a heat treatment that could possibly homogenize the microstructure. However, solution treatments at 1650°F and 1825°F were not successful in diffusing the copper out of the beta layer and the resultant microstructure

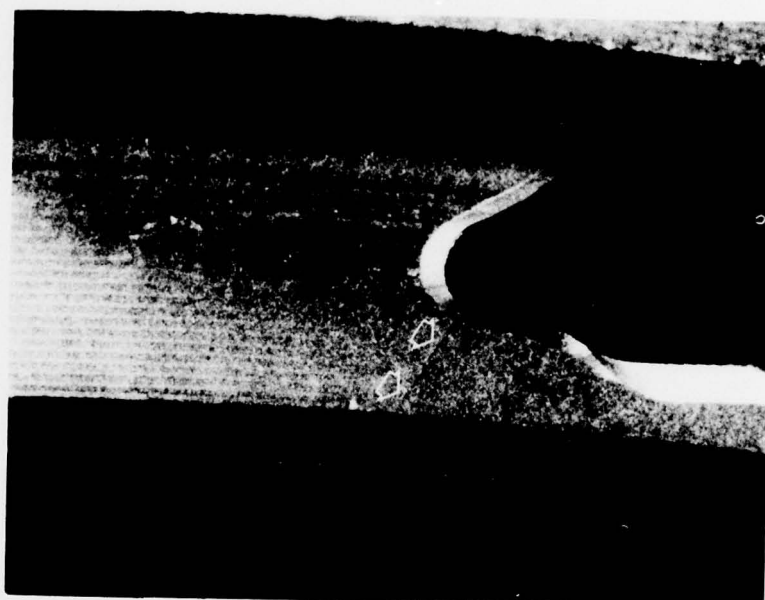
Figure 53. Crack Extending from the Dovetail on the Face of HIPped Compressor Disk S/N 4843. (Arrows Show Crack) MAG: Approx. 3X.

The early crack initiation could have been caused by a number of conditions; (1) surface contamination during HIP, (2) chemistry changes on the surface, and (3) relaxation of the residual stresses caused by the original machining and broaching of the disk dovetails. To investigate these possibilities, detailed Scanning Electron Microscope (SEM) analyses, Auger Spectroscopy,

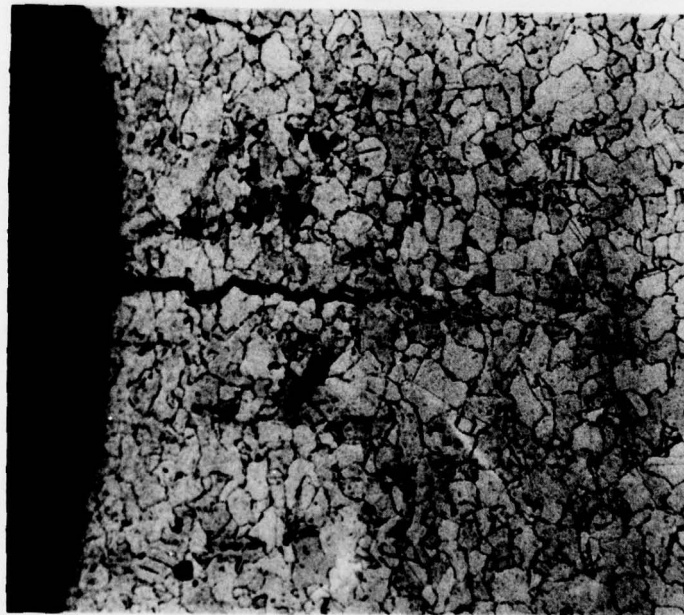
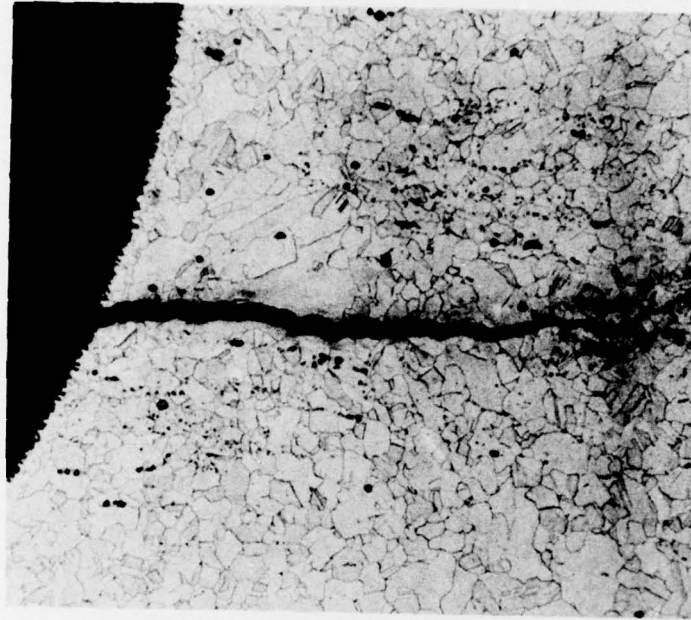
Figure 57. Appearance of Fatigue Cracks at the Base of Firtrees in Field-Service Disk Serial No. 90149A and in Cyclic-Spin Tested HIPed Disk Serial No. 2909. Mag.: 200X
